Aluminum wiring

Many of the cabins at Aspenhof were built when aluminum wiring was popular. While lighter and less expensive, aluminum has some disadvantages when used as electrical wiring.

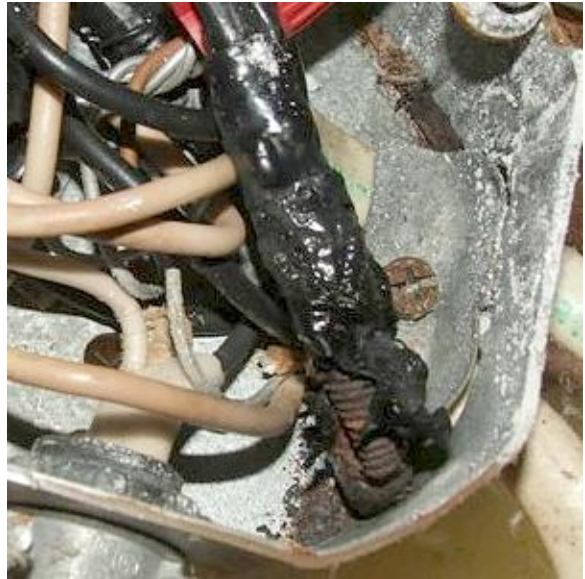
When the wiring cools again the connection will be loose. The next time current passes through this loosened connection the higher resistance causes it to overheat and a fire is possible. Notice how the wire nuts and tape in the lower right corner of this junction box have melted.

The thermal coefficient of expansion of aluminum is greater than that of copper. In a typical connection the wire will be pinched between two parallel surfaces such as the underside of a screw head and the face of the mounting plate beneath it. Since the aluminum wire expands more than the surrounding copper parts when temperature increases, and since aluminum deforms easily, the expansion forces it to flow sideways, assuming the shape of a flattened oval.

Aluminum also oxidizes very quickly in air and if connectors do not break through the oxidized surfaces a high-resistance connection results. This is often overcome by applying an oxide-inhibiting paste inside the connector.

This phenomenon could be abated by the use of connections designed specifically for aluminum wiring but not all electricians used them. In my own cabin I checked several circuits and was able to tighten the connection screw as much as a full turn on some.
